Manhole Inspection Summary

Manhole # S55S__014MH

Insp Date: **5/27/09 8:10 AM**

Location Address: **1501 S HIGHLAND AV**

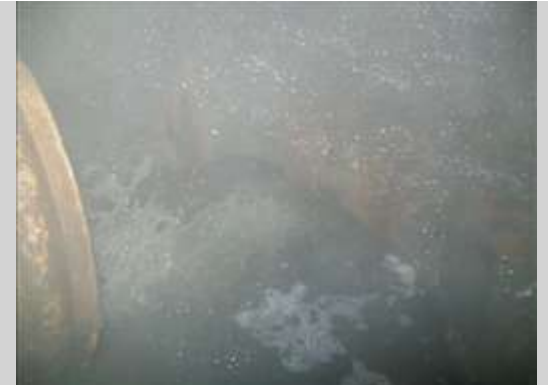
12 O'Clock Outflow

24 in. Circular Gravity Sewer
Pipe Out @ 12 O'Clock

Pipe Height: **24** (in.) Rod and Bar (Angled)
Pipe Material: **Unknown** ☐ Pipe Lined
Invert Depth: **23.10** (ft.) Flow Characteristics: **Fast**
Deposits: ☒ None ☐ Mud ☐ Sludge ☐ Debris ☐ Grease
Silt Depth: **0** (in.) Deposits Extent:
Infiltration: **None** Pipe Seal Cond: **Unknown**

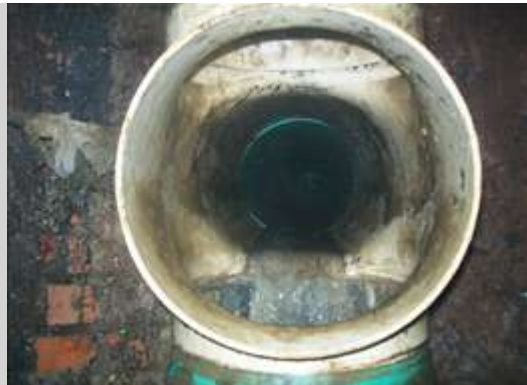
9 O'Clock Inflow

12 in. Circular Gravity Sewer

Pipe In @ 9 O'Clock

Pipe Height: **12** (in.) Rod and Bar (Angled)

Pipe Material: **PVC** ☐ Pipe Lined

Infiltration: **None** Pipe Seal Cond: **Sound**

Drop: **Inside** **Rod and Bar**
Angled: **Yes** Reading: **21.80** (ft.)
Inv Depth: **22.80** (ft.)
Drop Condition: **Open**
